# Quality Control Inspection of Homes with Thermal Imaging

Sampling of Thermal Images collected during a study of construction quality of homes built recently in the five most populous parishes of Louisiana

Performed By  
James E. Davidson  
Infrared Thermographer  
Associate Architect  
While under contract to LADNR

Study was completed in the Fall of 2001

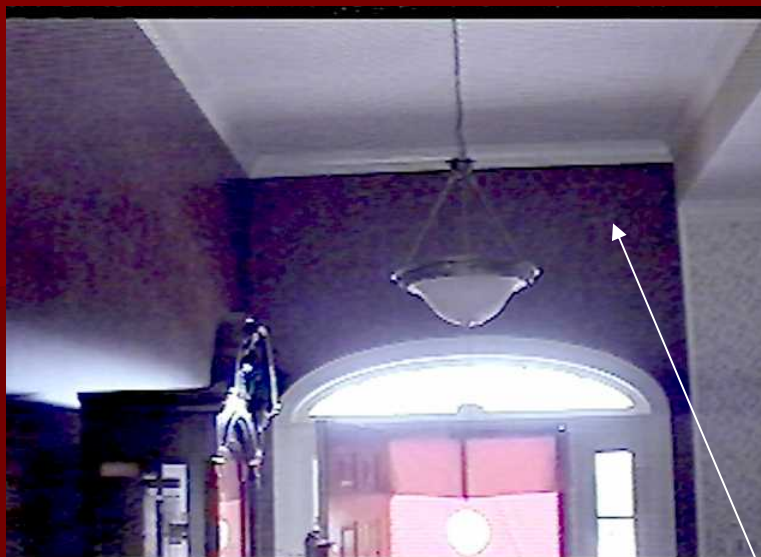
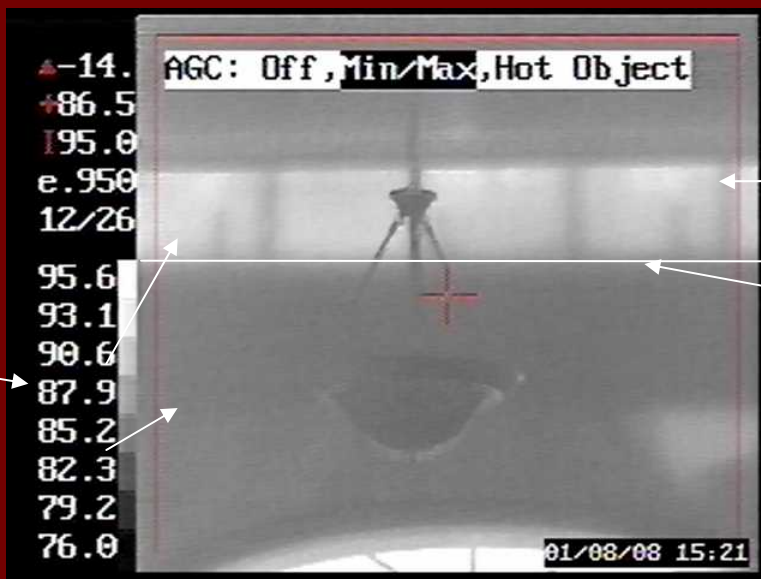
Note temperature difference between insulated section and void – approximately 5.4 degrees.

Knee wall void @ top

Outside porch ceiling line

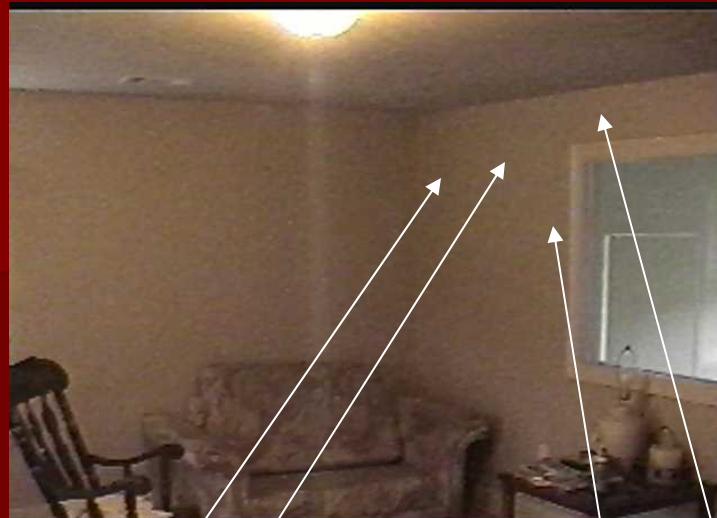
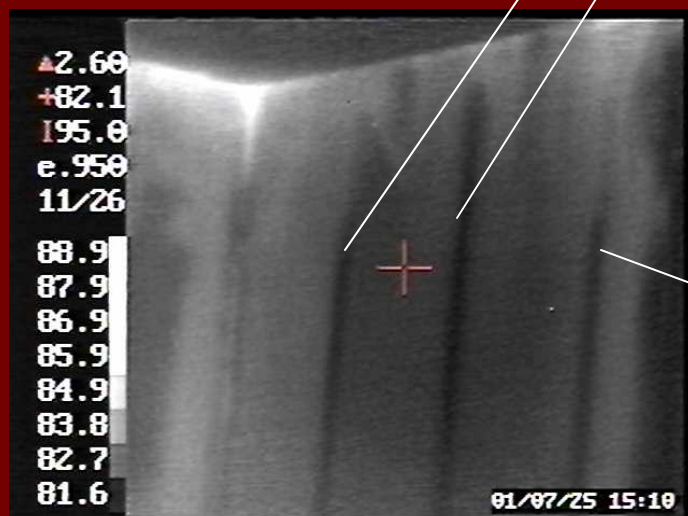
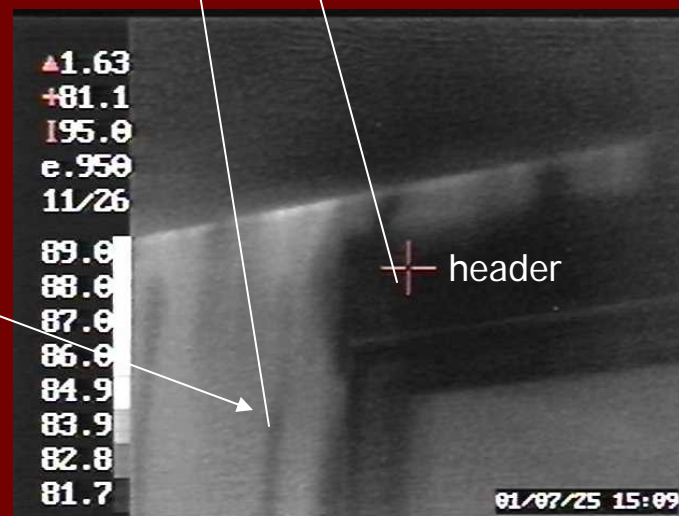
The black lines are studs in an interior partition separating a spa room from a game room. The studs should be continuous to the ceiling. But hot air seeping down into the partition is causing the sheet rock to heat up hiding the cooler stud pattern.

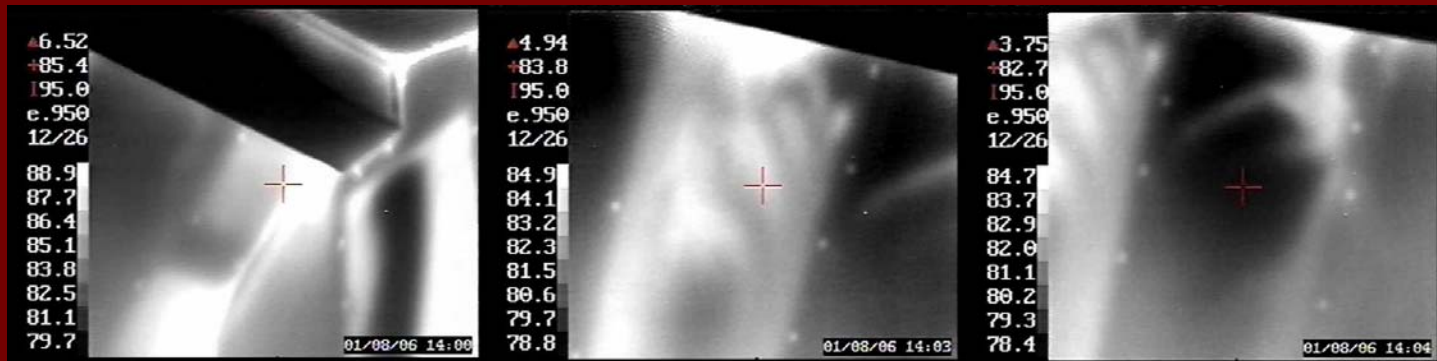
Insulation voids caused by poorly attached fiberglass batts. Note the odd pattern below the ridge beam in the left image. This is a knee wall with the batt against the drywall where the dark area is showing but hot spots on either side from poor contact between the studs. The other images show voids in the cathedral ceiling along the other side of the ridge beam. Note the nail heads acting as thermal bridges in the rafters and studs of each image.

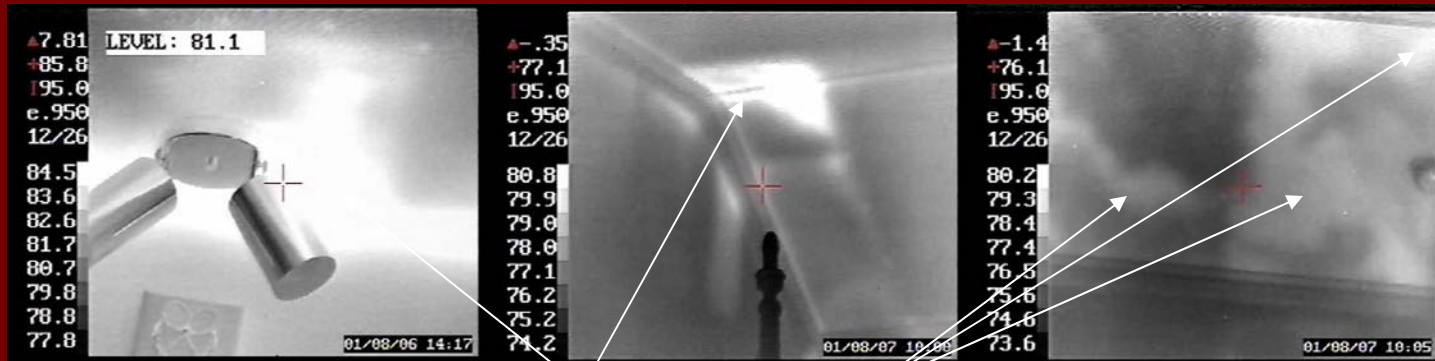
Insulation voids

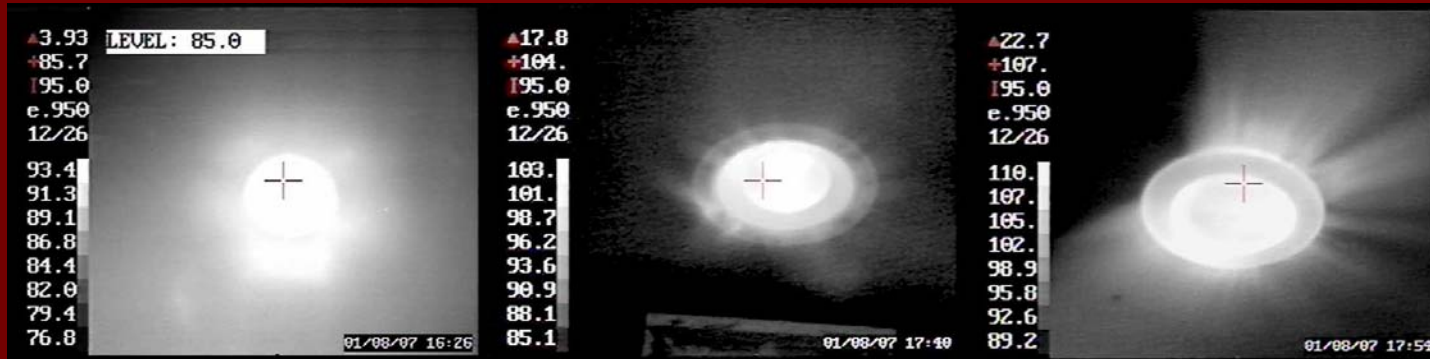
Unsealed down lights & leaking escutcheons

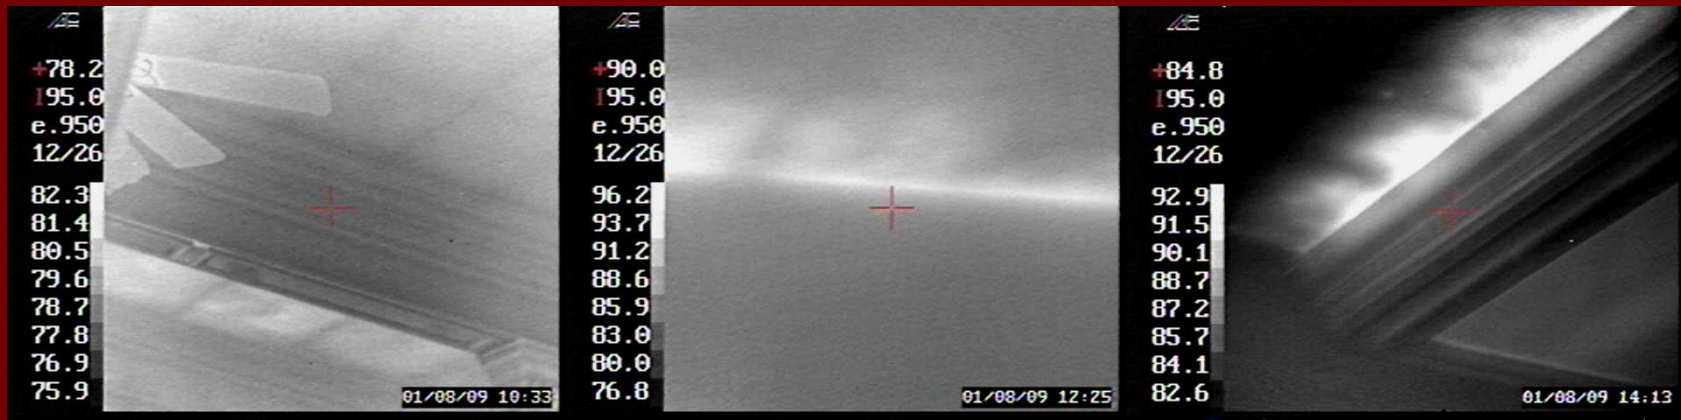
Poorly distributed blown-in insulation

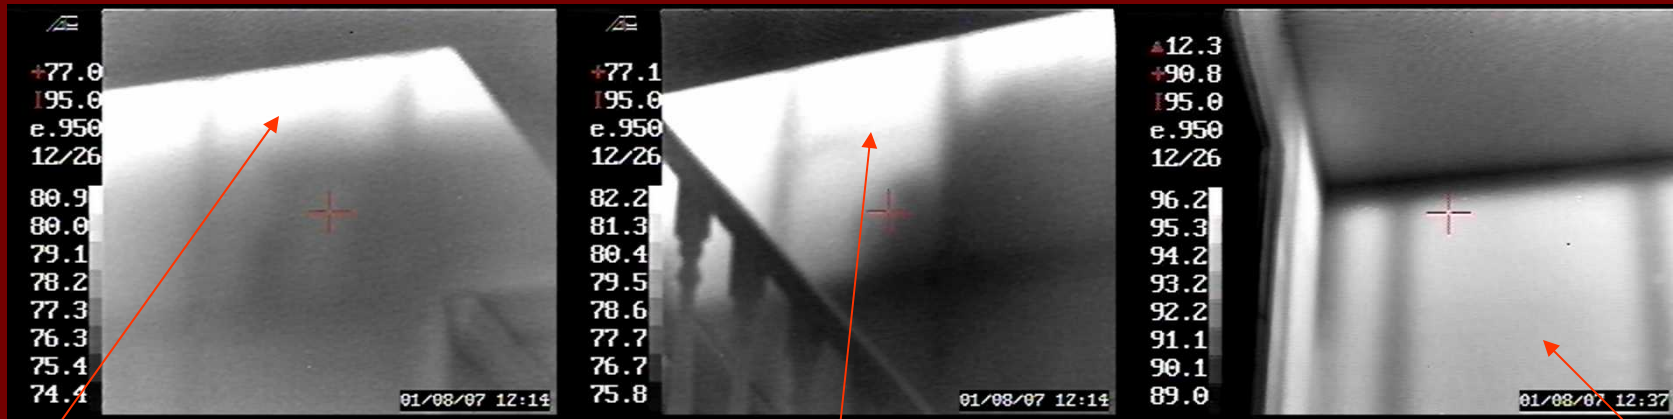
Insulation voids that are actually knee walls since the attic is on the other side. This is a stairwell.

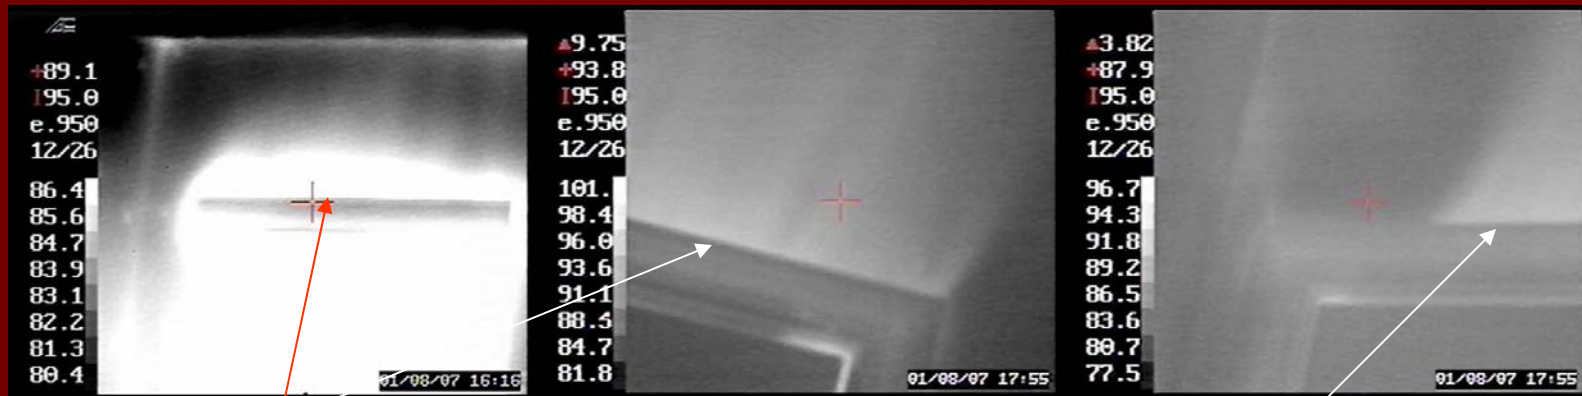
Air leaks at window and door frames from poor caulking jobs.

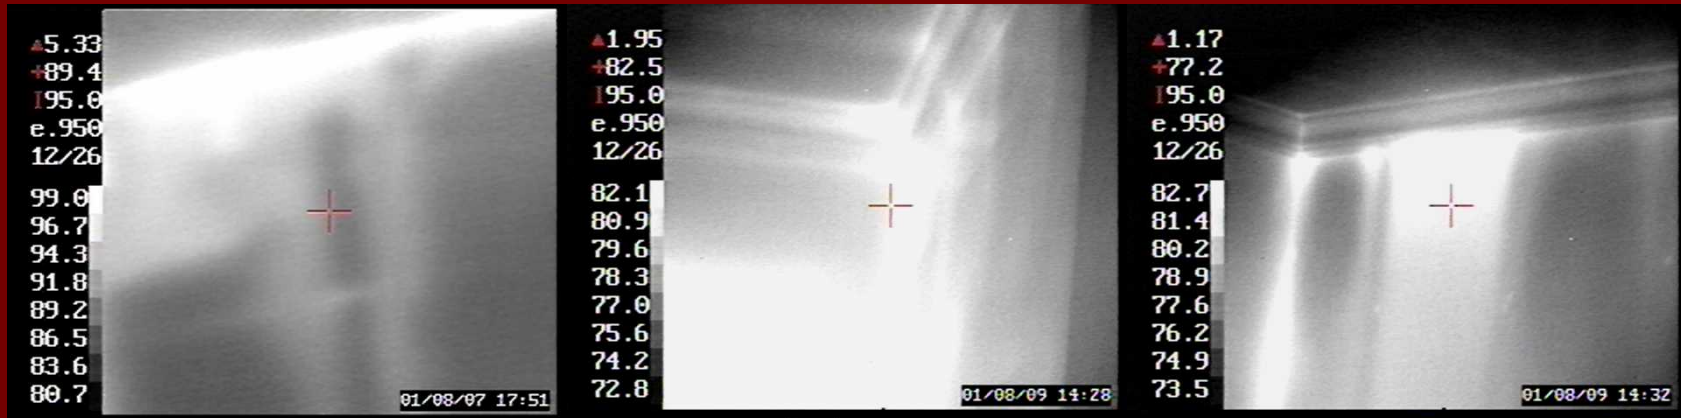
Insulation voids and leaking top plate.

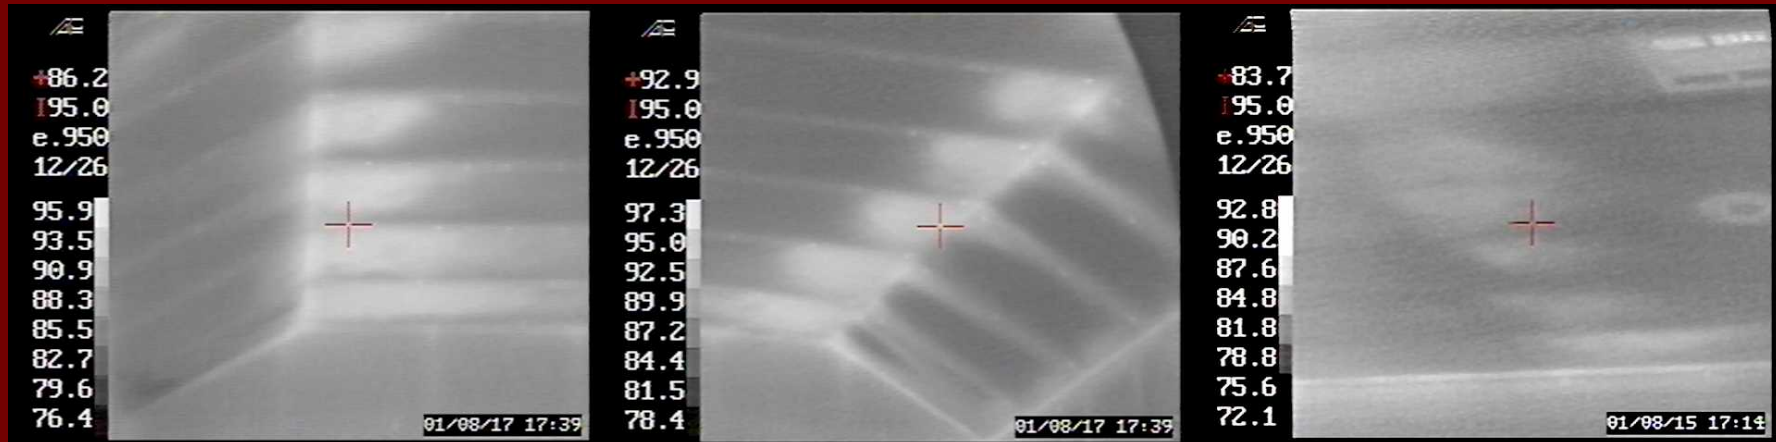
Poorly distributed blown insulation

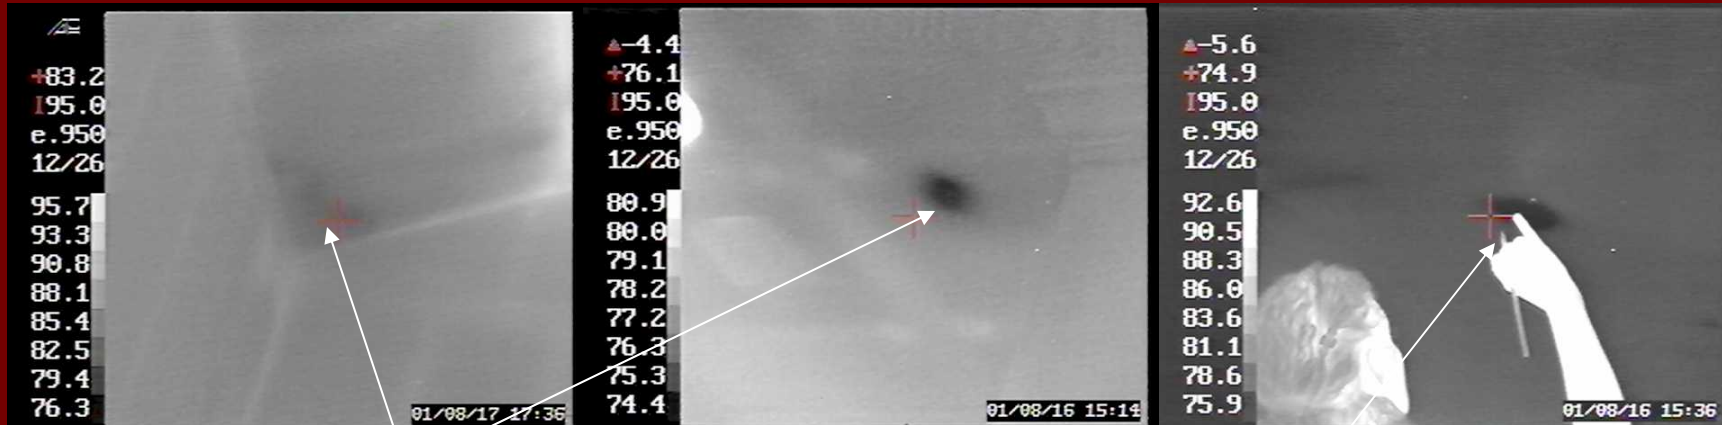
Roof leaks showing from evaporation pattern in ceiling.

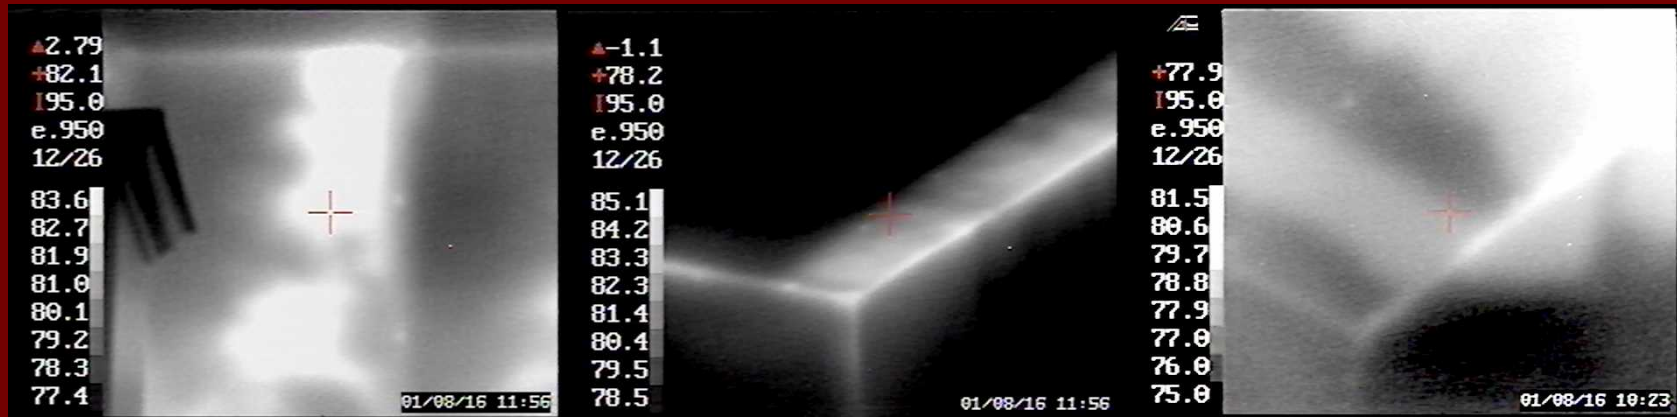
Poorly distributed blown insulation

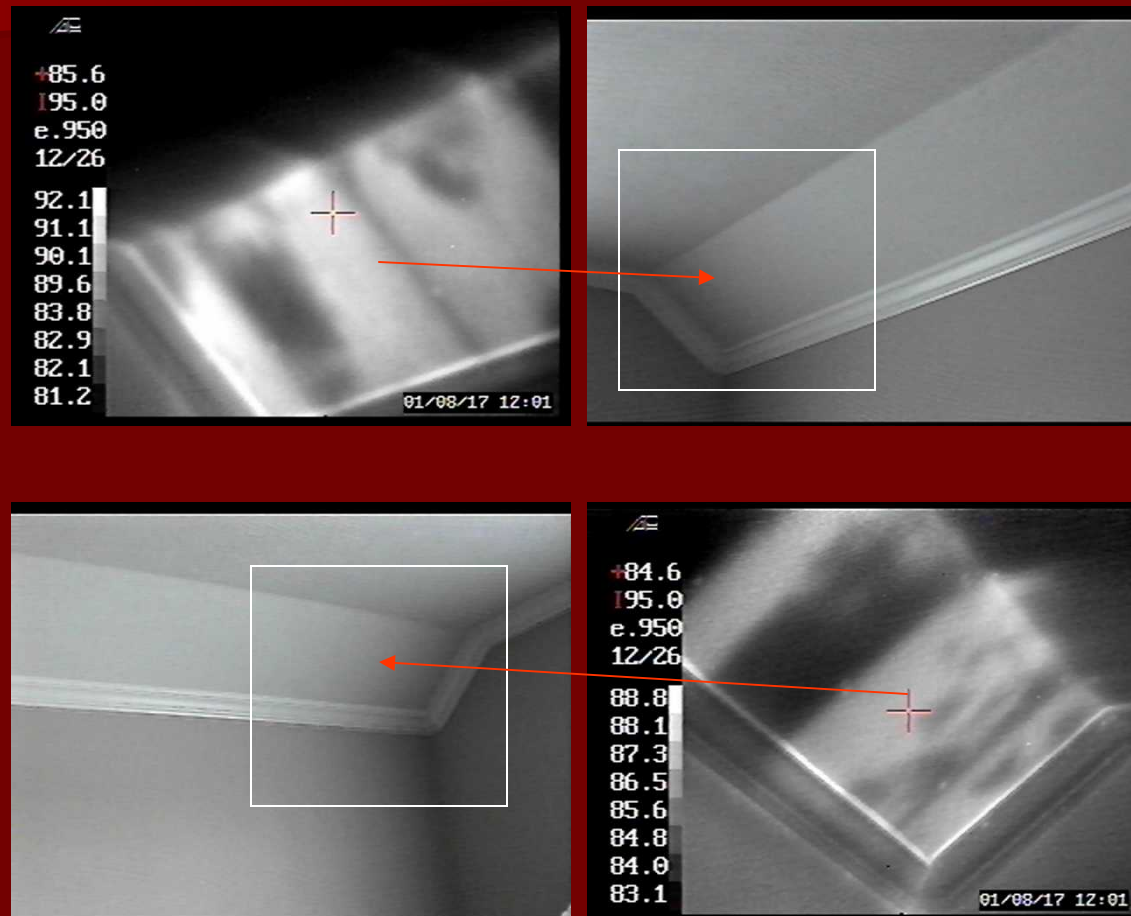
More blown insulation defects.

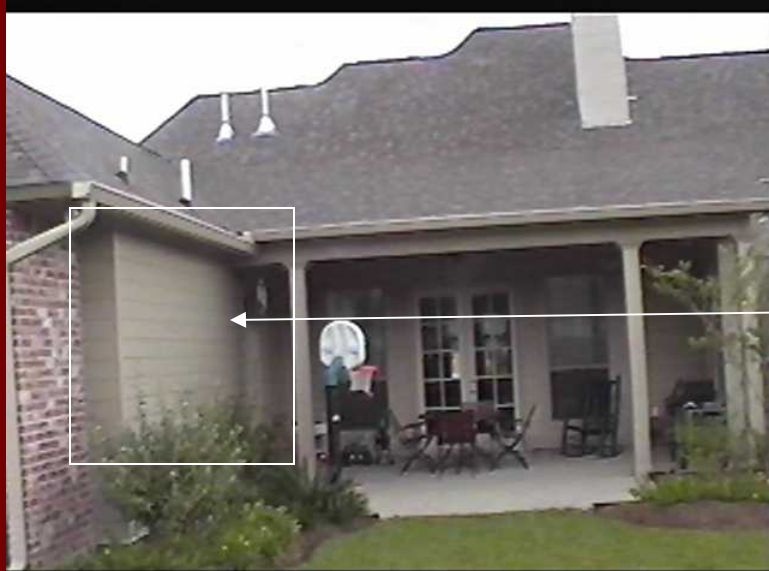
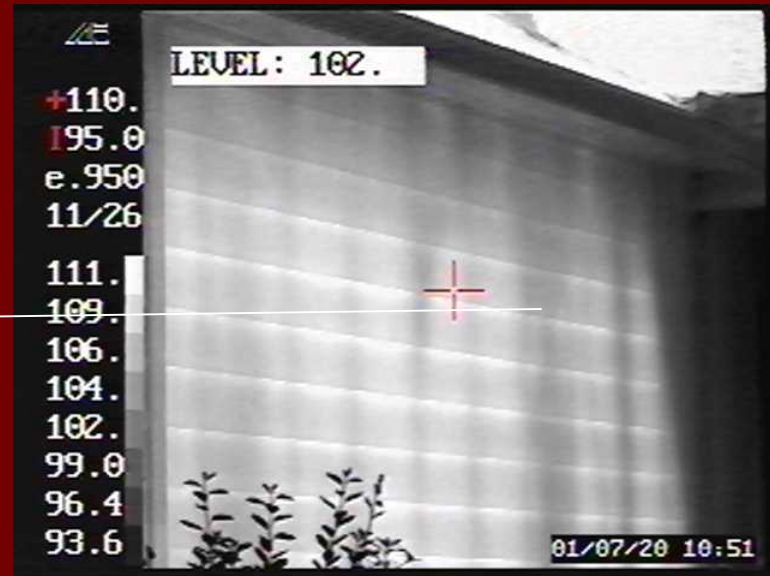
Insulation voids

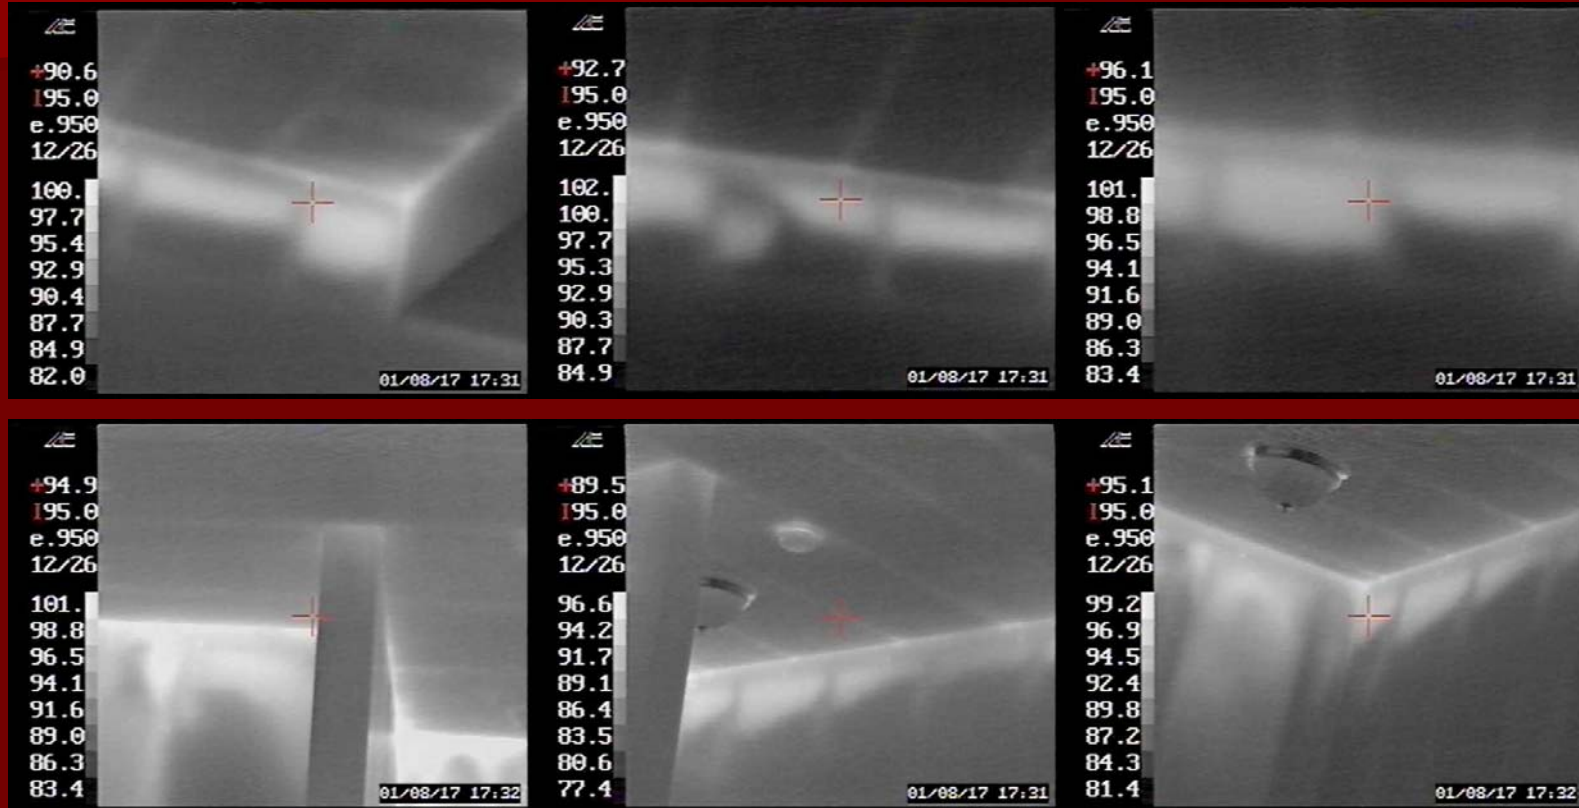
Hot spots from voids at the top of the walls in the Great Room.

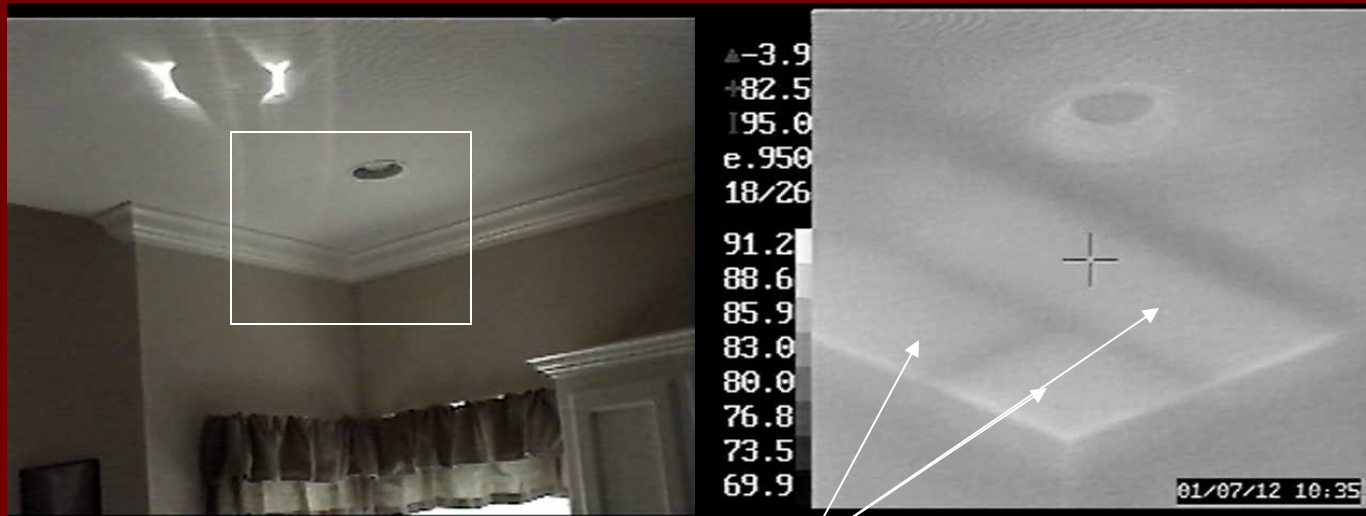
Missing batts

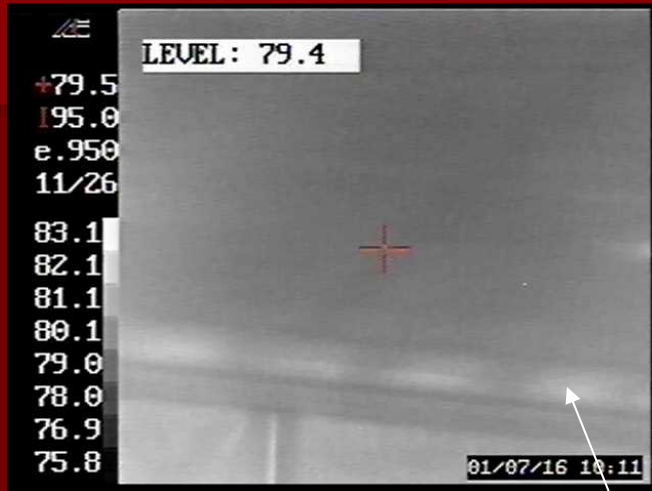
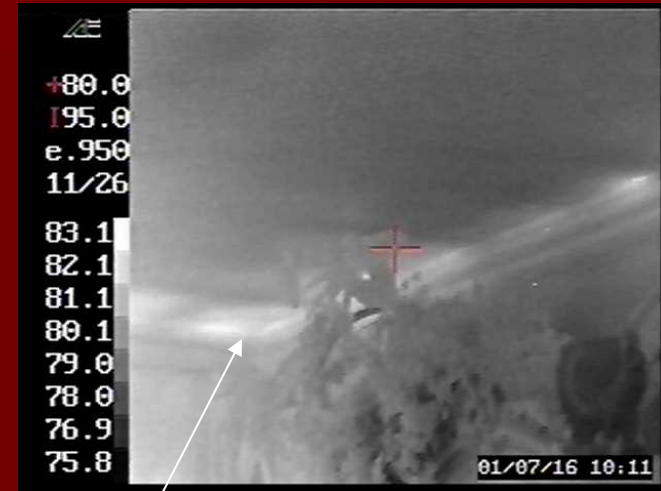
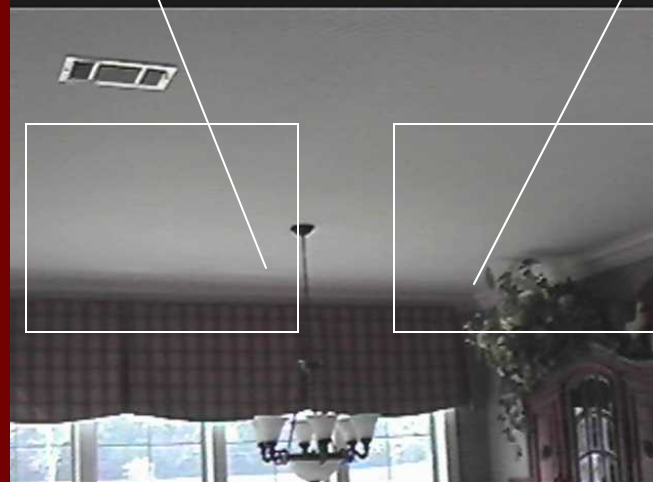
If you don't check the workmanship this is what you get.

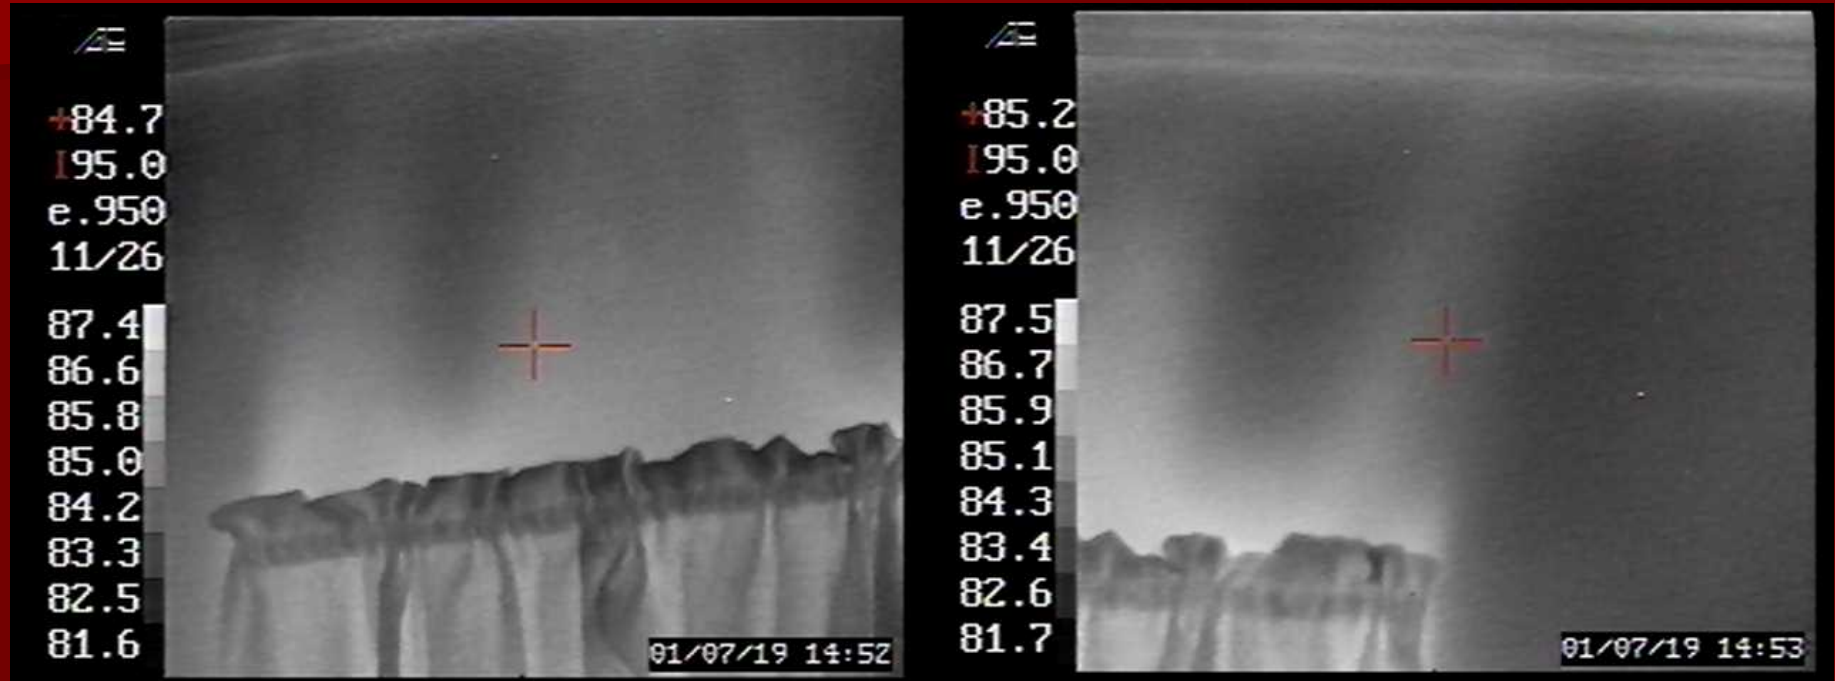
Why pay \$100+ per square foot when caulking is so cheap and so forgotten?

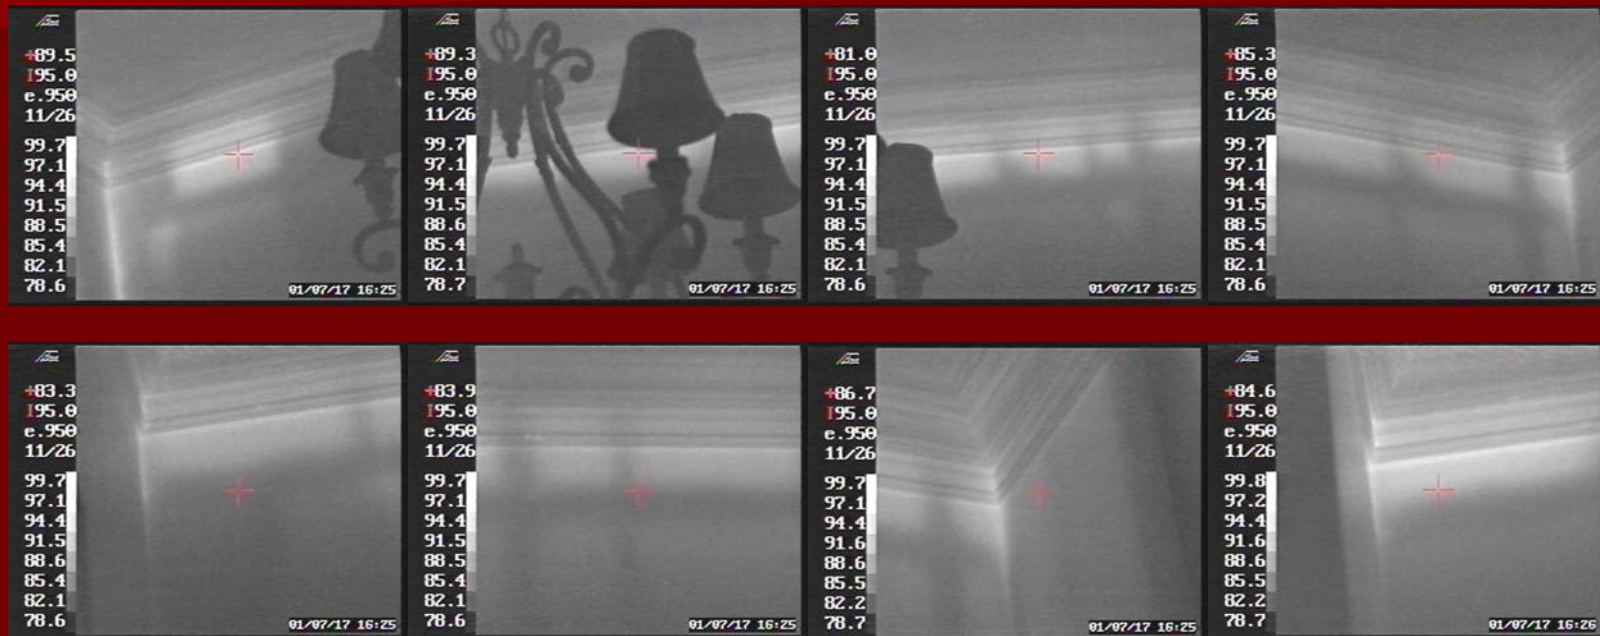
The above knee wall extends from one side of the house to the other! If you spend \$250,000 for your home, does this mean that you can afford to pay high utility bills?

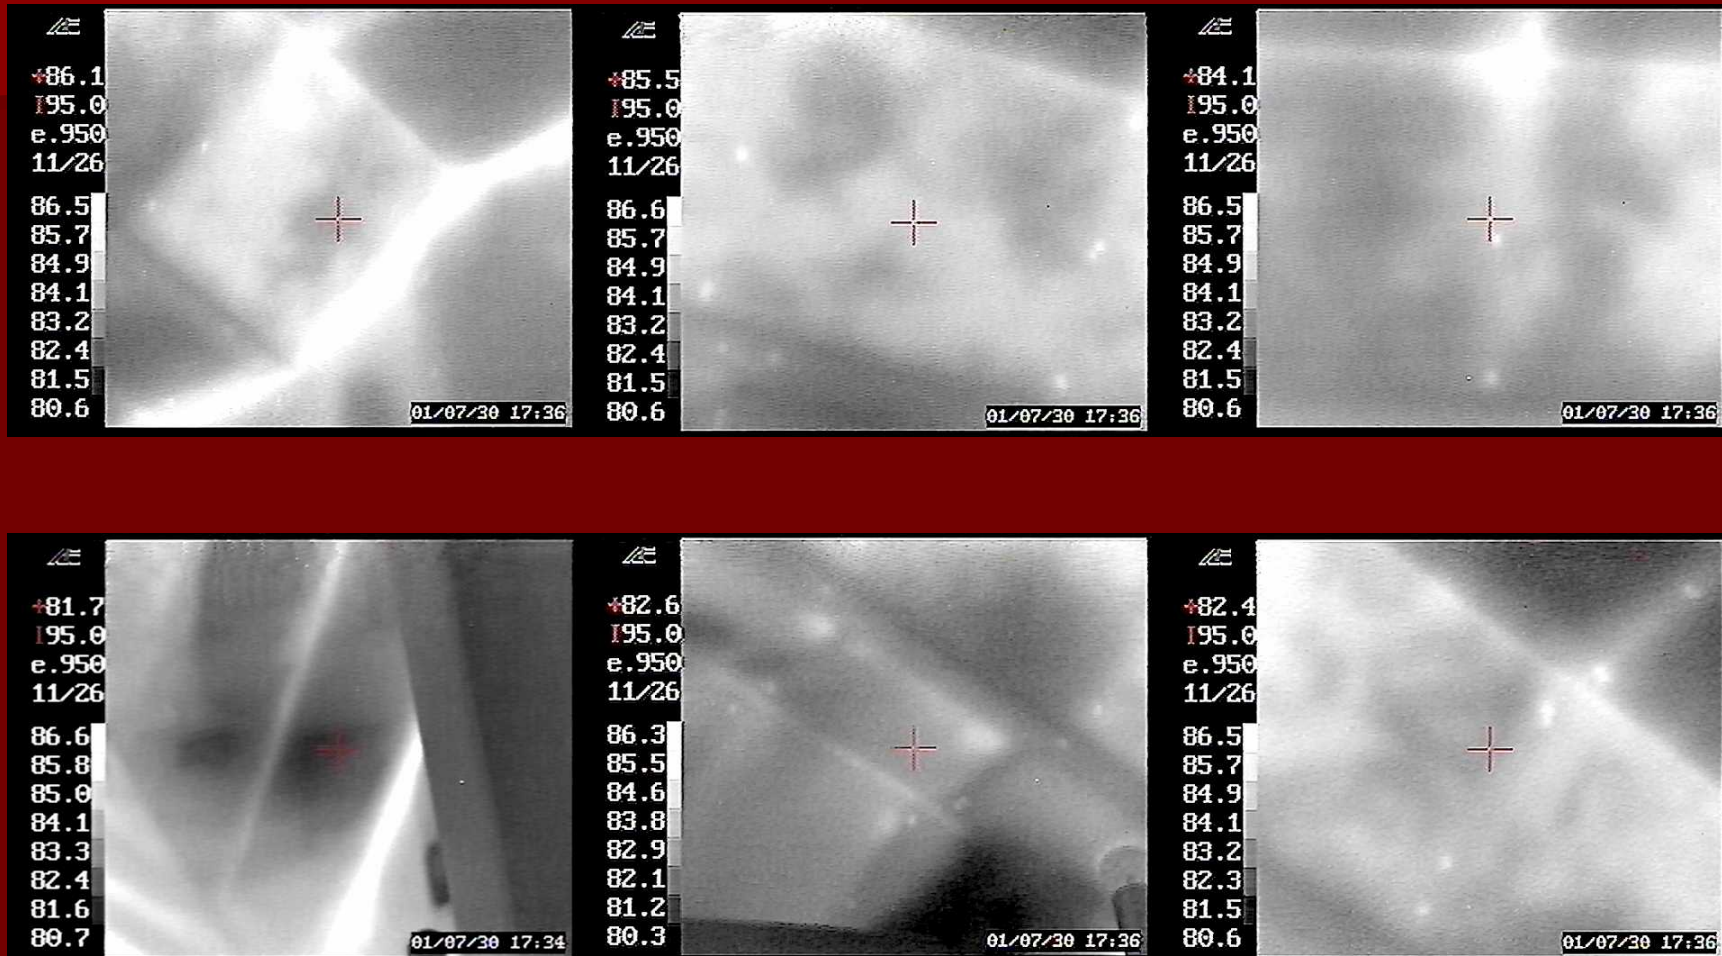
Cathedral ceilings and loose blown insulation aren't a good combination.

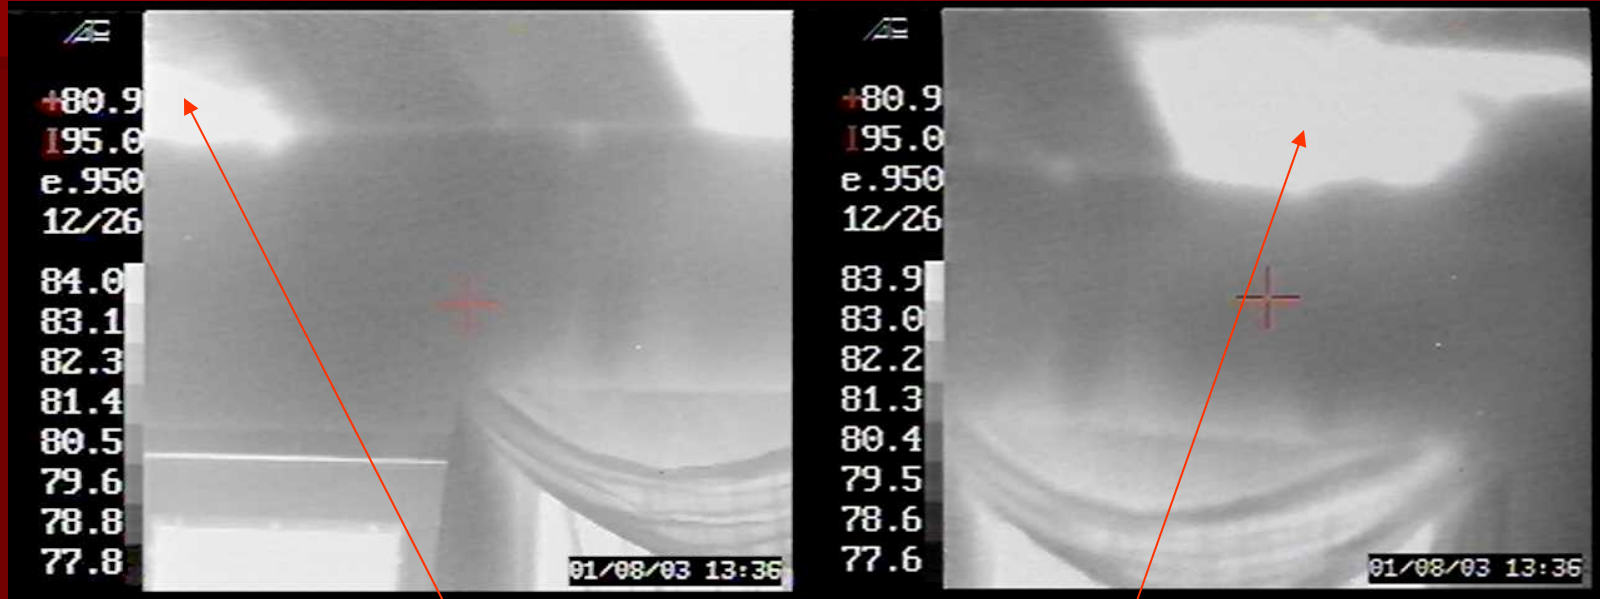
Sloppy workmanship is across the state.

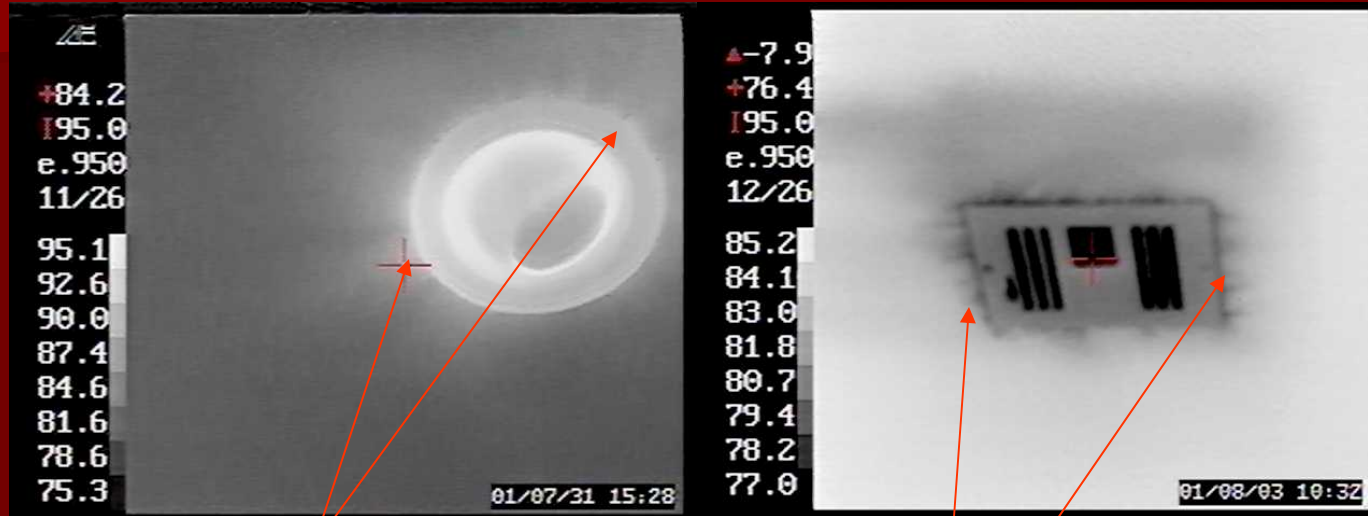
Escutcheon plates leak too without gaskets!

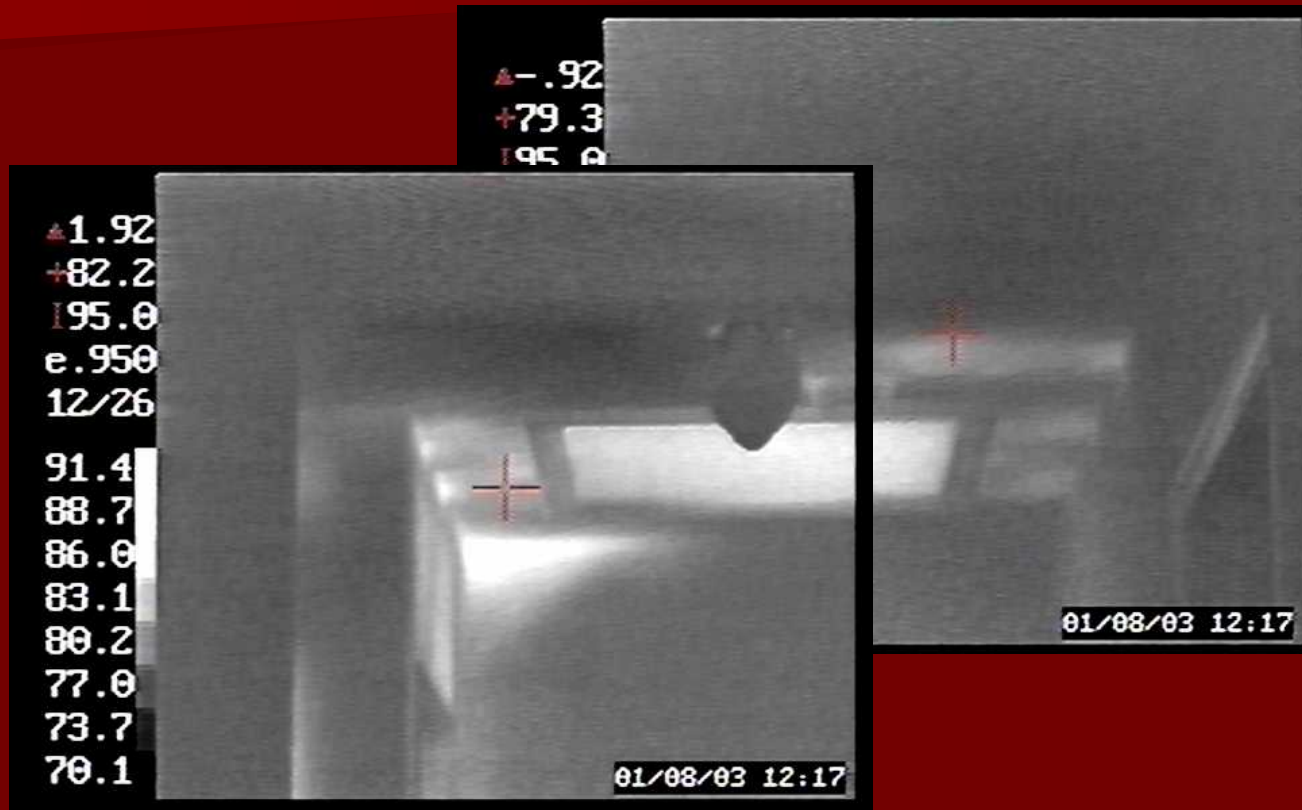
Overlapping images show the extent of voids in a hallway around an non-insulated stair hatch.

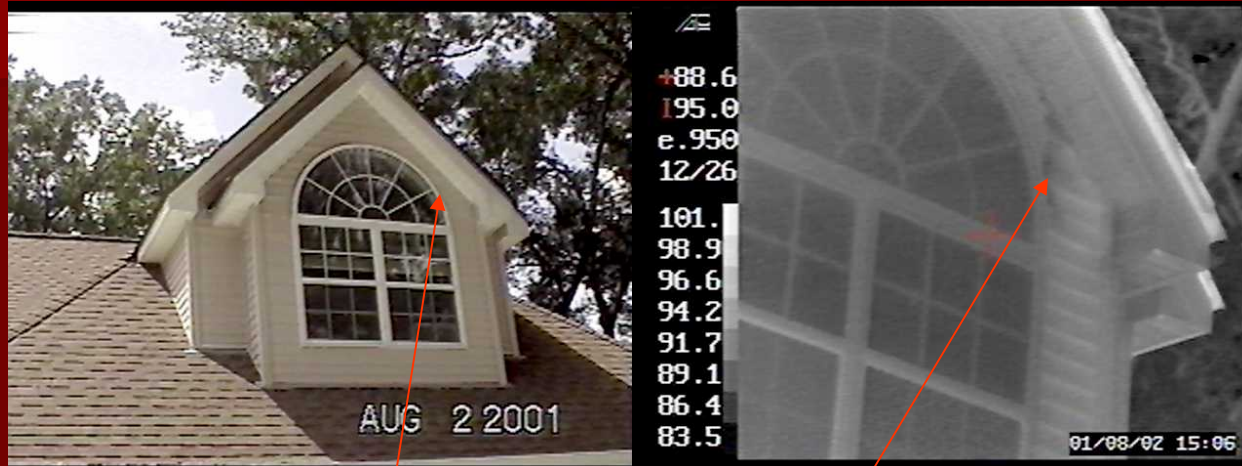
Leak above dormer window!

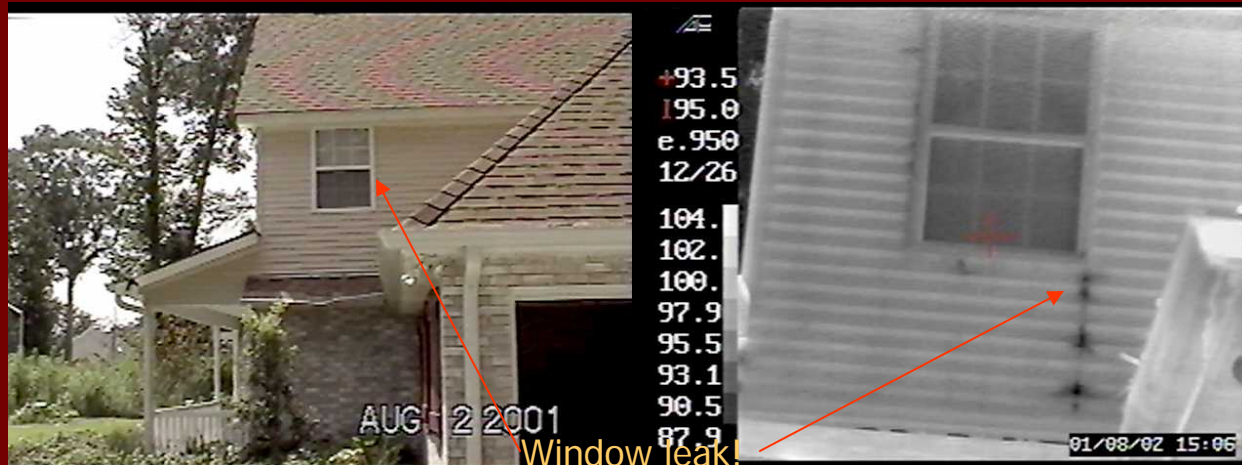
Window leak!

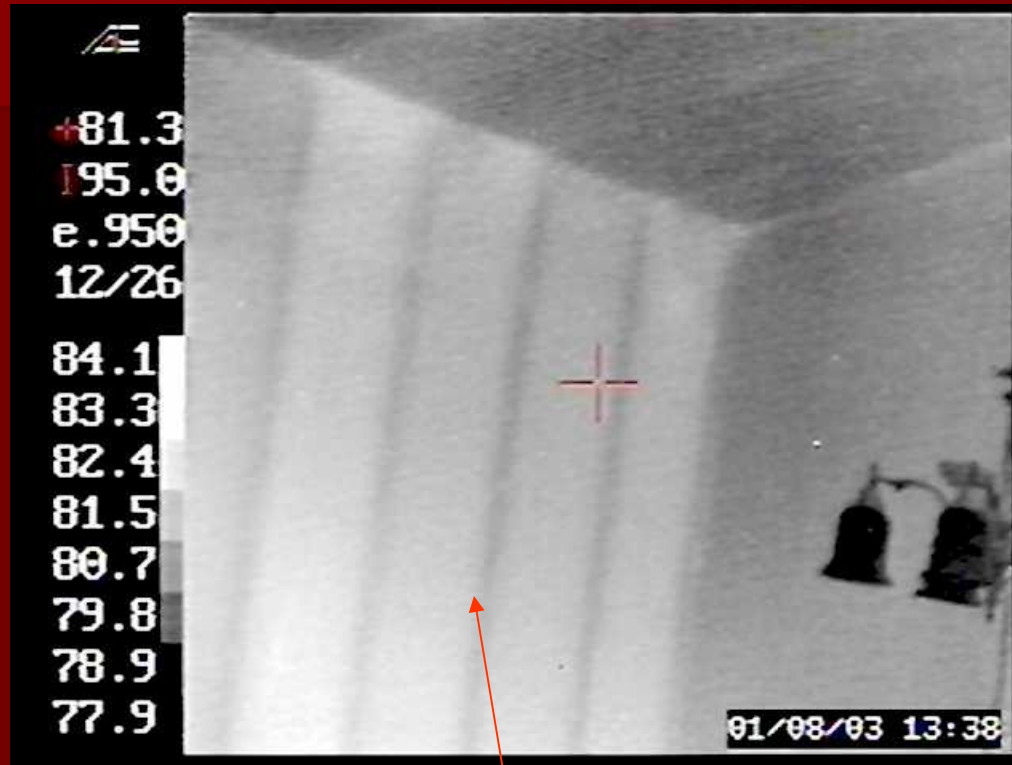
Chimney chase that is open to the attic and therefore a knee wall.
