# Quality Control Inspection of Homes with Thermal Imaging

Sampling of Thermal Images collected during a study of construction quality of homes built recently in the five most populous parishes of Louisiana

Performed By  
James E. Davidson  
Infrared Thermographer  
Associate Architect  
While under contract to LADNR

Study was completed in the Fall of 2001

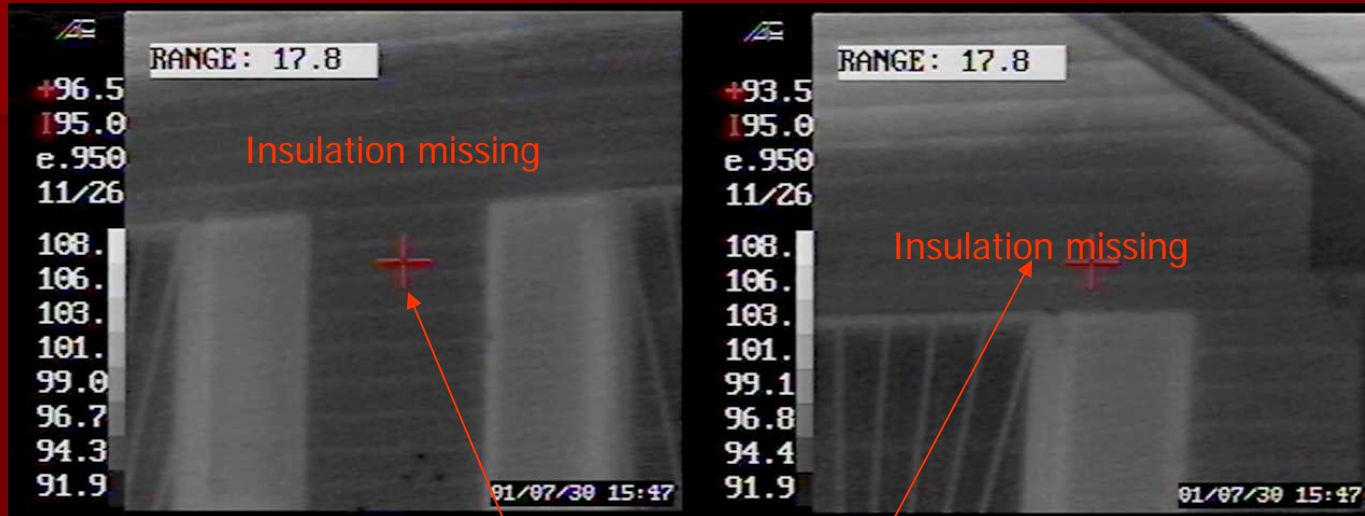
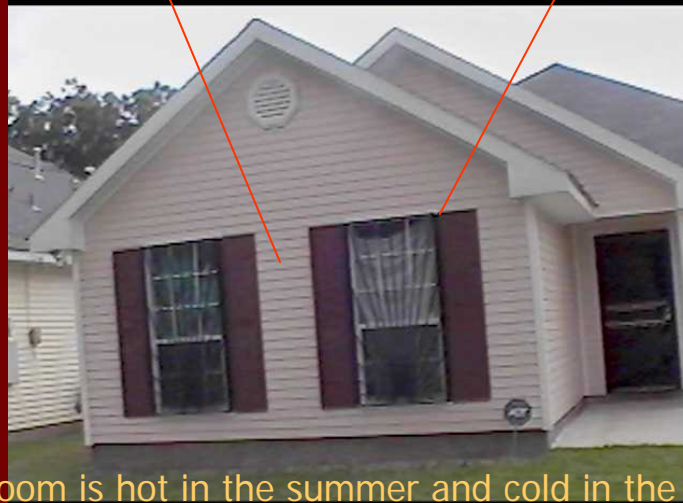
This room is hot in the summer and cold in the winter.

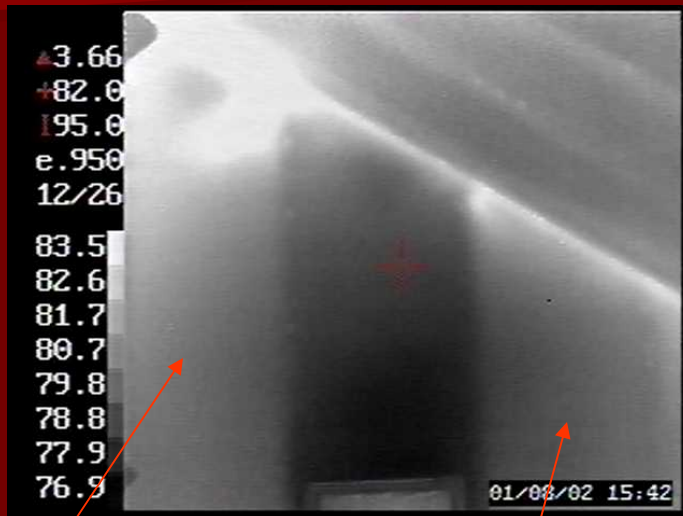
One out of three insulated sections isn't a good average.

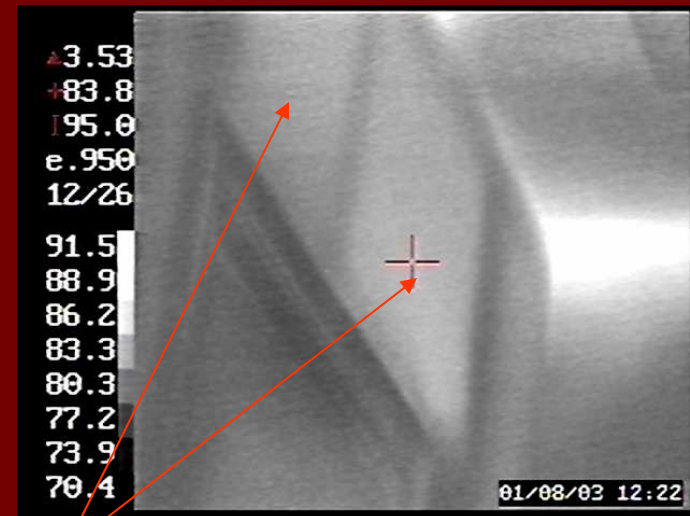
Air handler closet walls open to the attic are knee walls that need insulation.

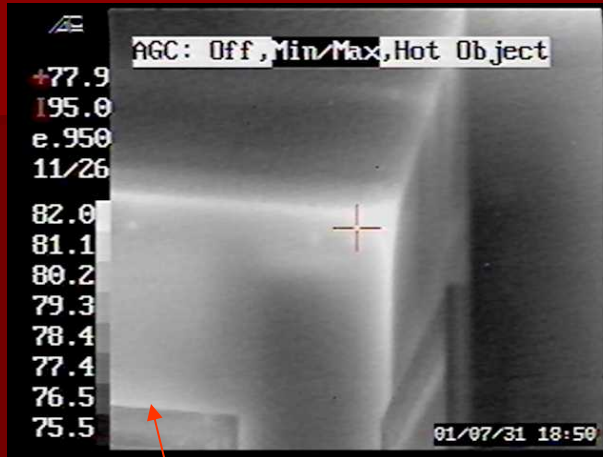
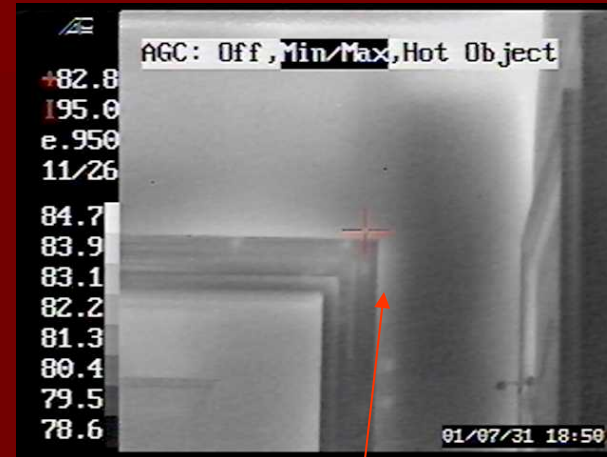
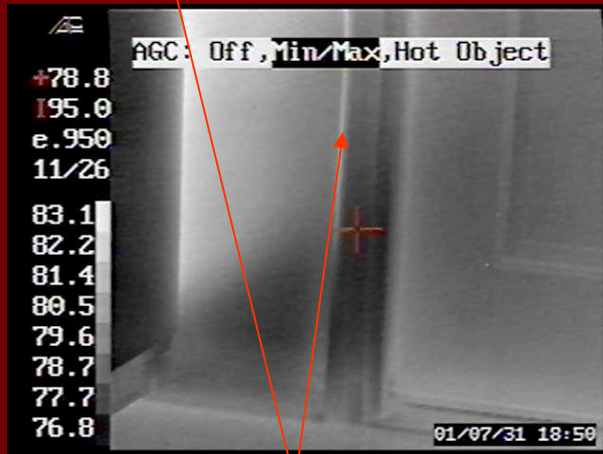
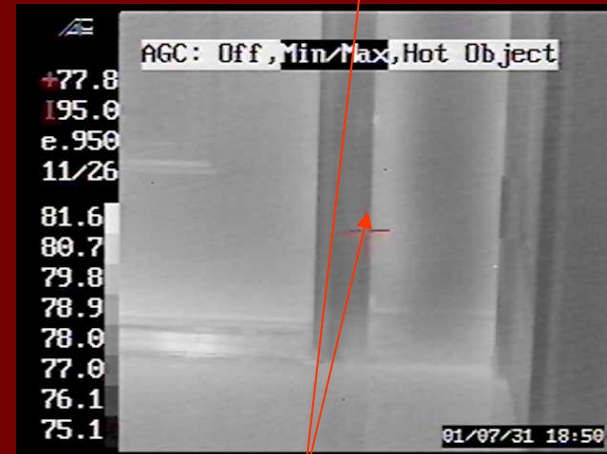
Doors need to be caulked in this parish too.

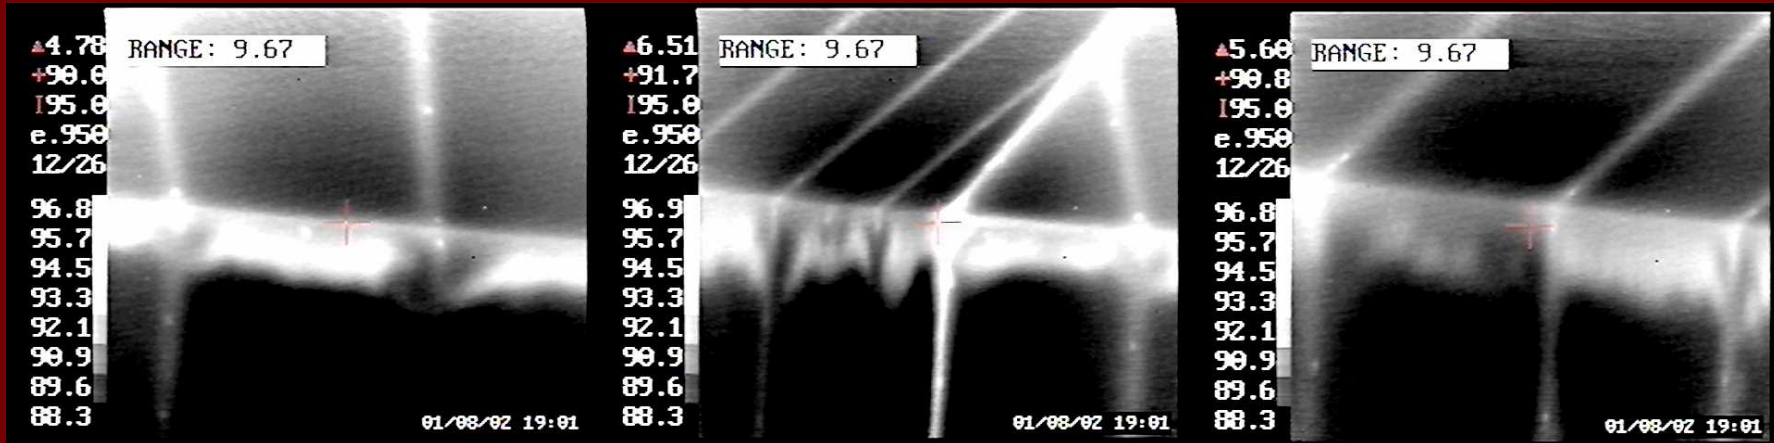
No wonder this room was so hot!

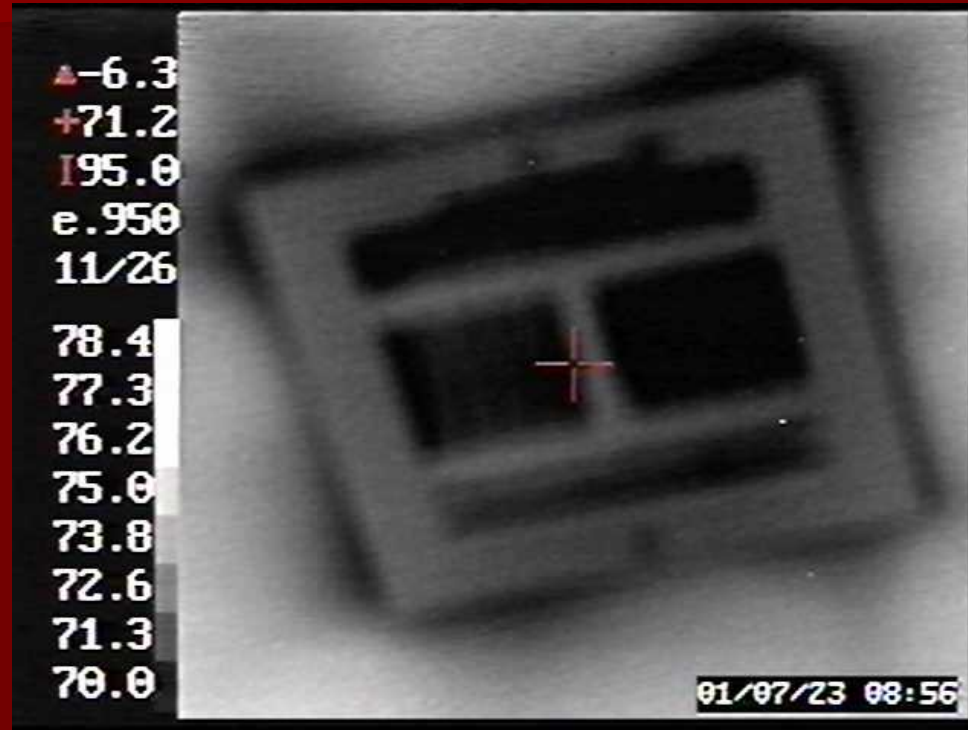
Missing gasket around escutcheon allows leaking.

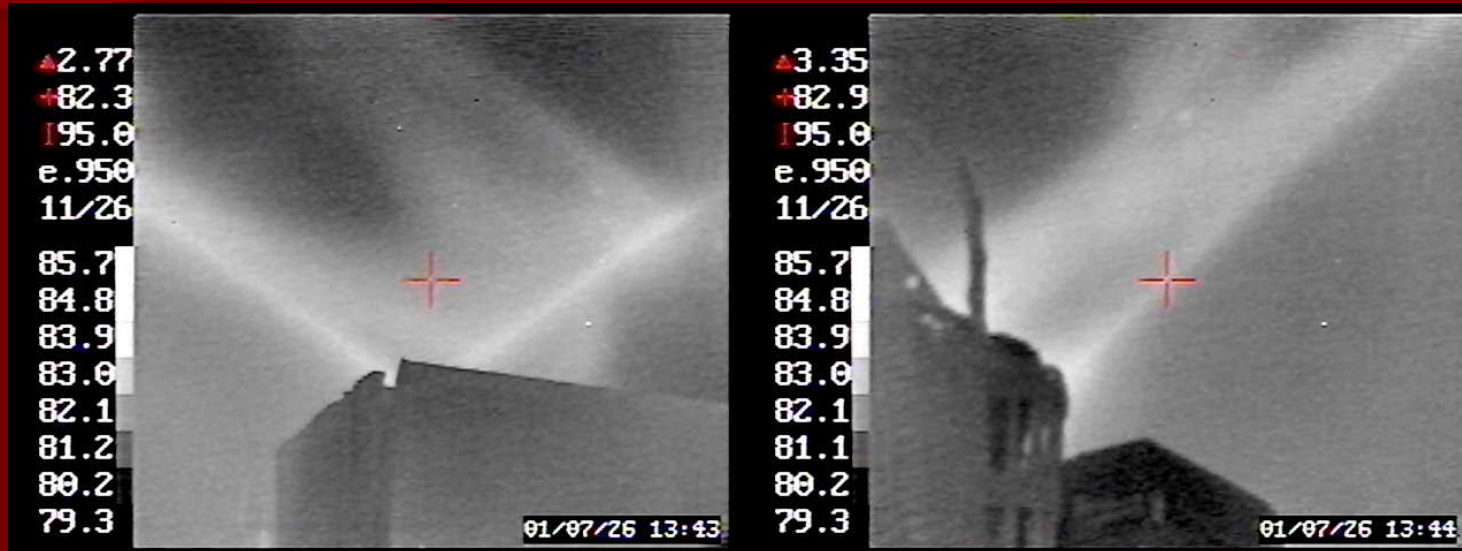
Master bedroom closets need ceiling insulation installed correctly too.

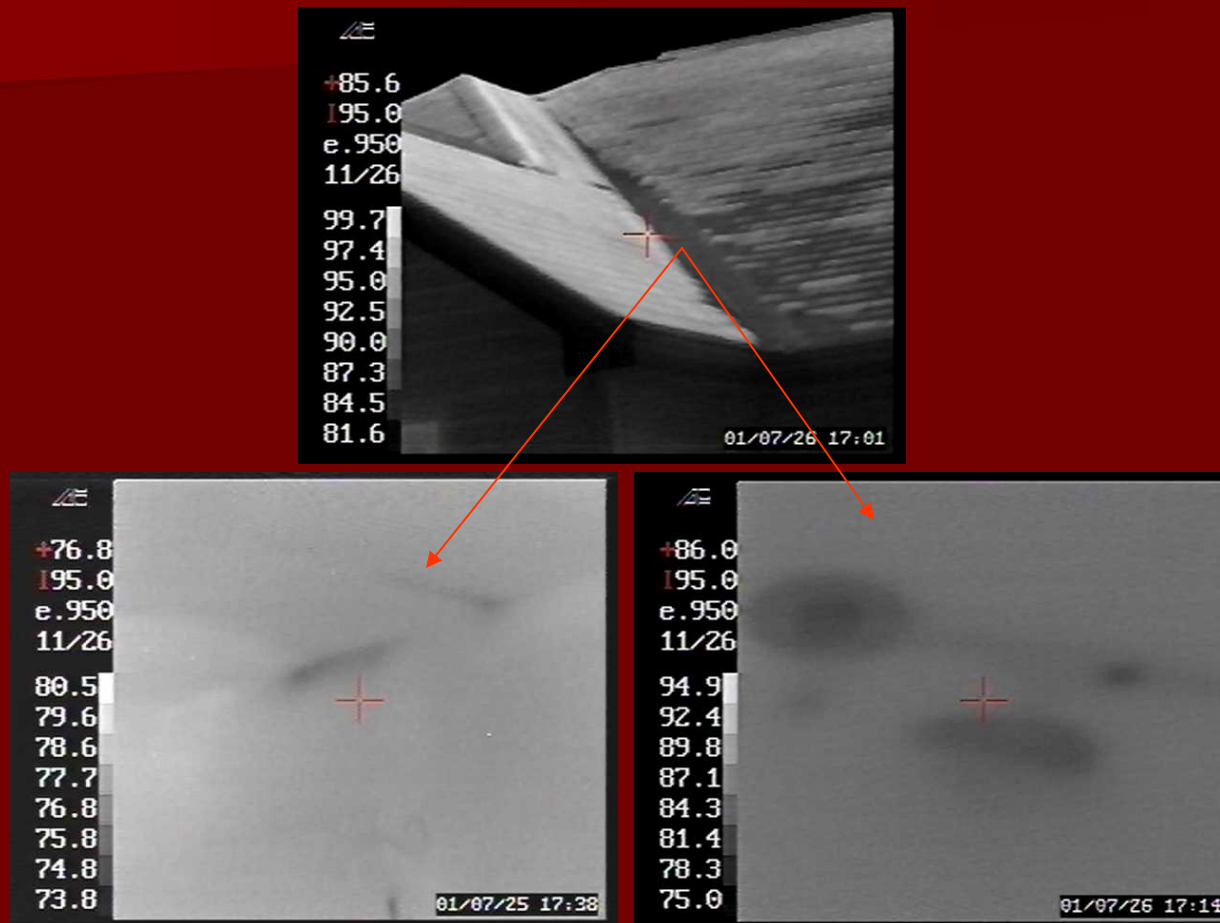
Leaking valleys cause wet ceilings.

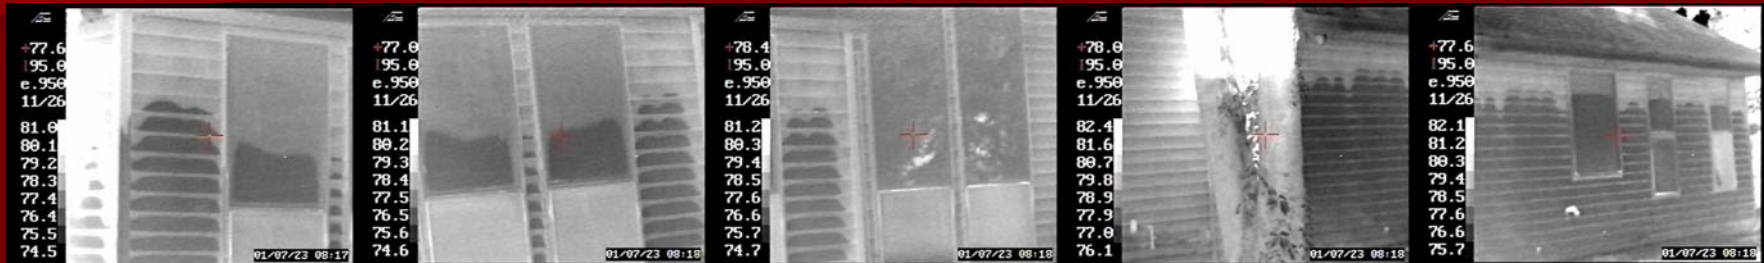
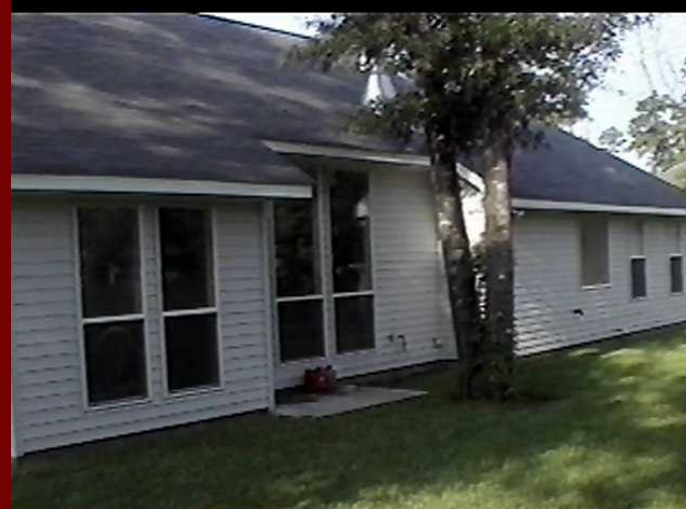
Odd condensation patterns on the surface of the vinyl siding across the back of this house may indicate a lack of insulation in the wall behind it.

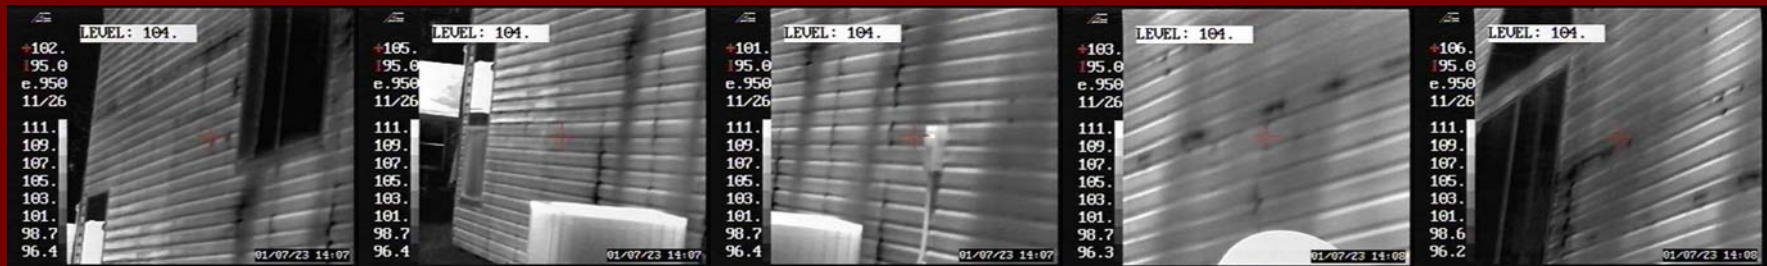
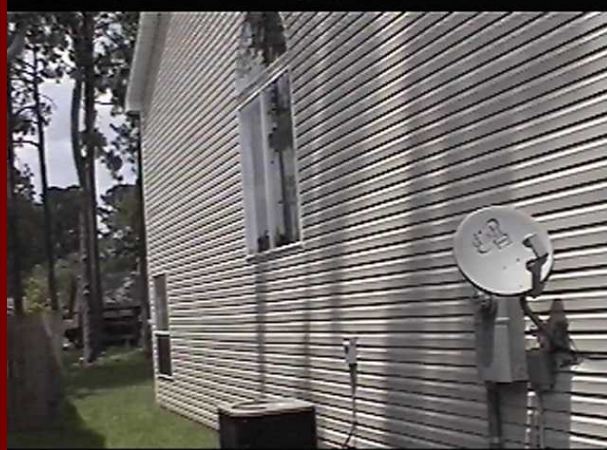
Vinyl siding leaks unmasked.

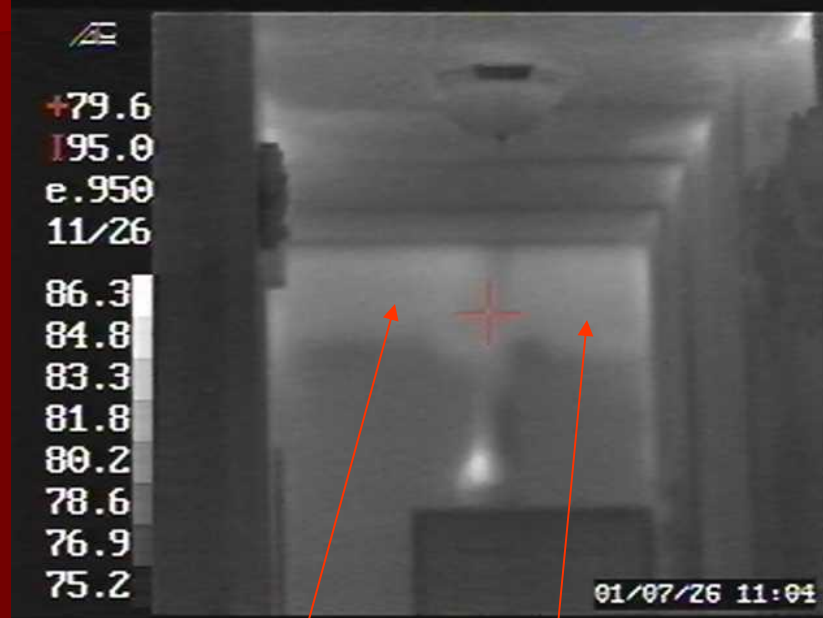
Insulation void
